Advanced Modification Guide

KIT 8 1998 & KIT 8 1999

DOCUMENT ID: 394I
REVISION: 2
DATE: 2022
LANGUAGE: EN

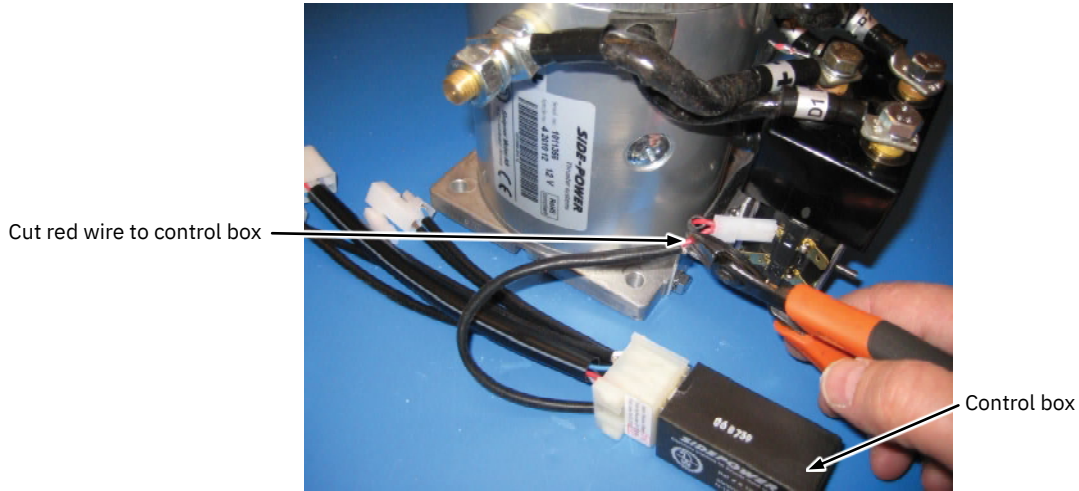
(Control box fitted on motors from 1999 onwards).

We require part of the existing loom as part of the modification. Cut the red wire (as shown in the illustration) so the connections to the 2 positive motor solenoid coil splay terminals and main positive terminal remains.

On removal of the existing motorloom, there may be one or two wires protruding the motor. These become redundant when modifying to a proportional system. Ensure that they are isolated from the motor housing or other electrical components.

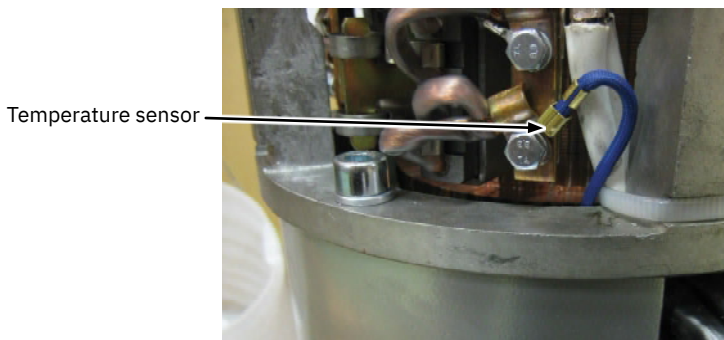
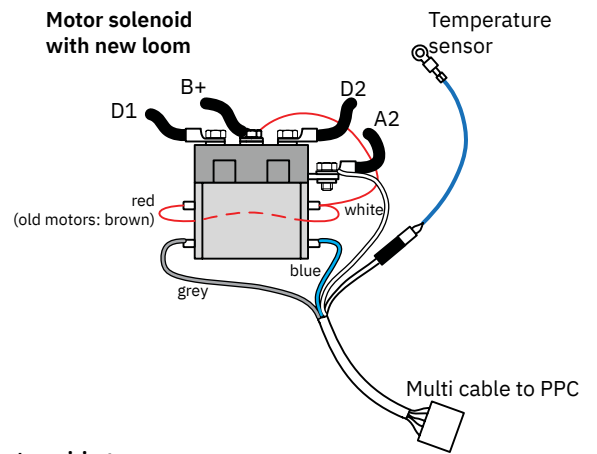
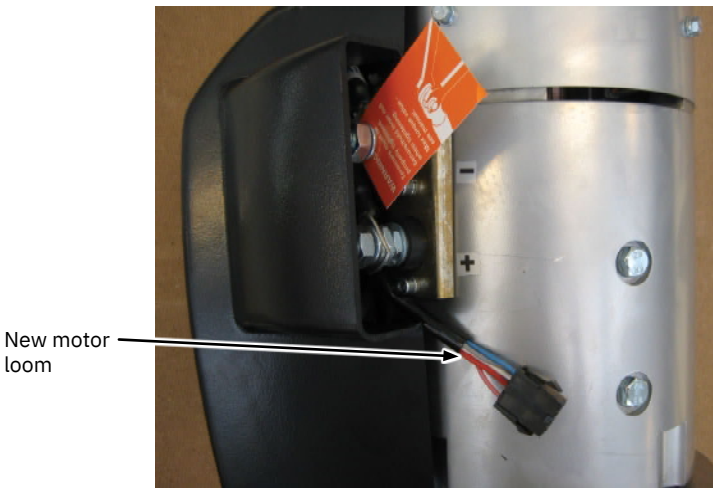
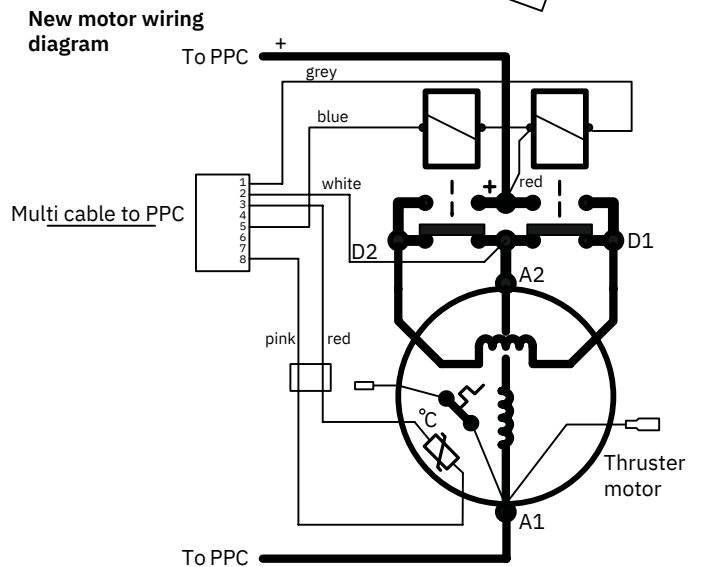
Installing the New Motor Loom

When installing the temperature sensor to the motor brush holder, care must be taken to avoid contact with the motor housing.

Connect grey and blue wires to the motor solenoid coils in the same position as the previous loom.

Connect white to the A2 terminal.
